PROJECT HIGHLIGHT – TRANSFORMER REPAIR

Early in 2021 while in shutdown mode, a Northern BC Mine had one of their two main transformers suffer a major failure.

Investigate the extent of the damage, determine repairability, procure materials, and implement the solution.

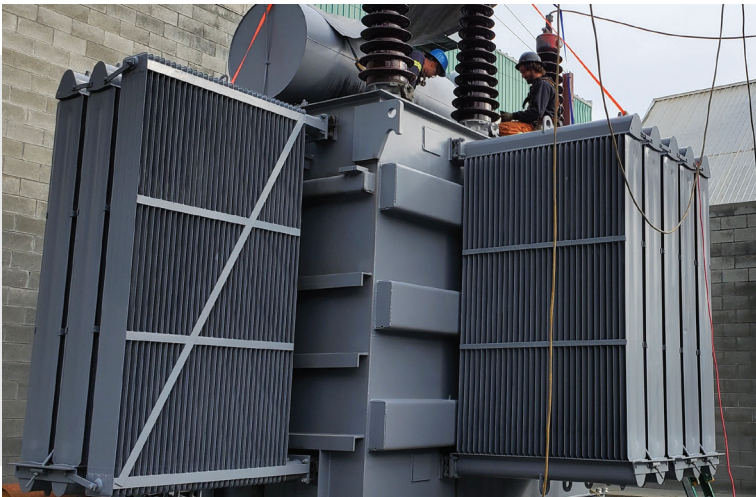
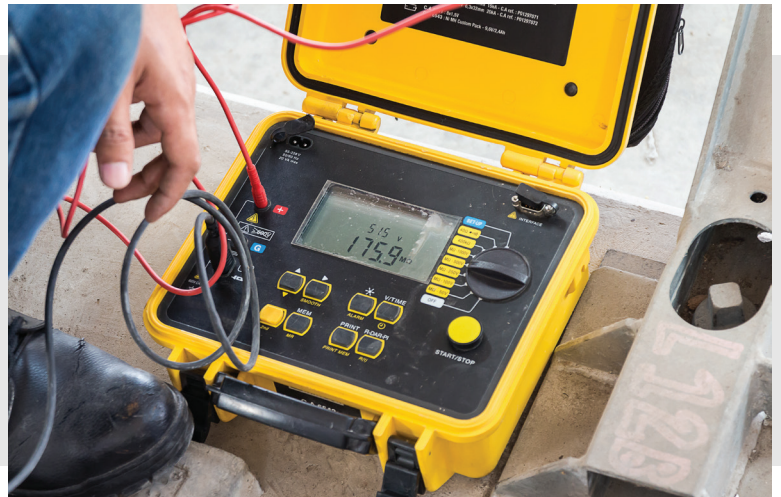
The first stage of testing determined that the insulation resistance of the secondary winding was low although power factor and dissipation tests of the primary windings and primary bushings were within acceptable ranges. At this time inspections of the insulating oil and other components of the transformer were conducted. With the initial stage of the process yielding potentially positive results, the second stage of the inspection was justified. Sweep frequency response analysis testing was completed before removing the transformer insulating oil to temporary storage. A thorough internal inspection on the windings and detailed measurements of the defective parts allowed for fabrication and procurement of custom LV bushings and mounting plates. A final site visit resulted in the installation of all new parts including custom welding of bushing mounting plates, installation of custom bushings, modification and re-design of transformer throat, re-design and re-wiring of protection circuits, leak repair, oil processing, and final testing and energization.
